FACTUAL AIRCRAFT ACCIDENT REPORT 02/2011

General Civil Aviation Authority

Air Accident Investigation Department

**Grumman G21G, N221AG
Al Ain International Airport
27th February 2011
United Arab Emirates**

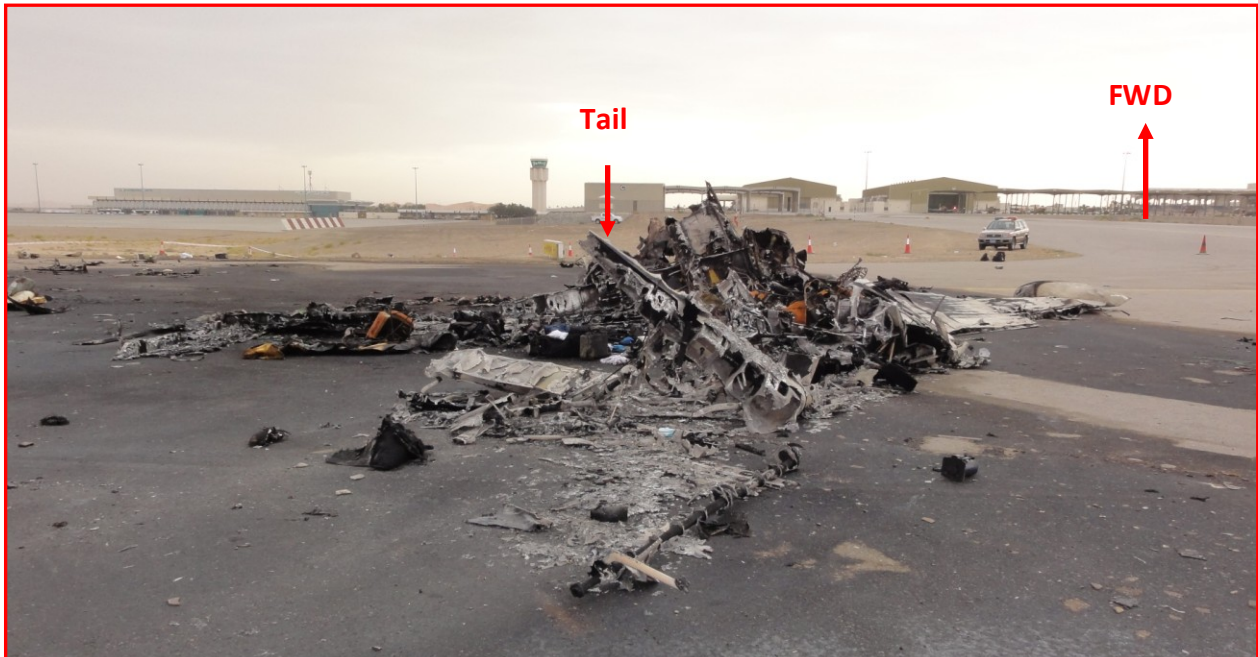
The main wreckage was almost one unit; the wings, flight controls, engines mainframe were damaged but stayed at their original place. The two propellers and the left hand tyre were found at various locations but close to the main wreckage. The cockpit was the most severely damaged zone where the windows scattered and the seats out of place (figures 1, 2 and 3 in the Appendix).

Figure 1- Main wreckage, looking Forward

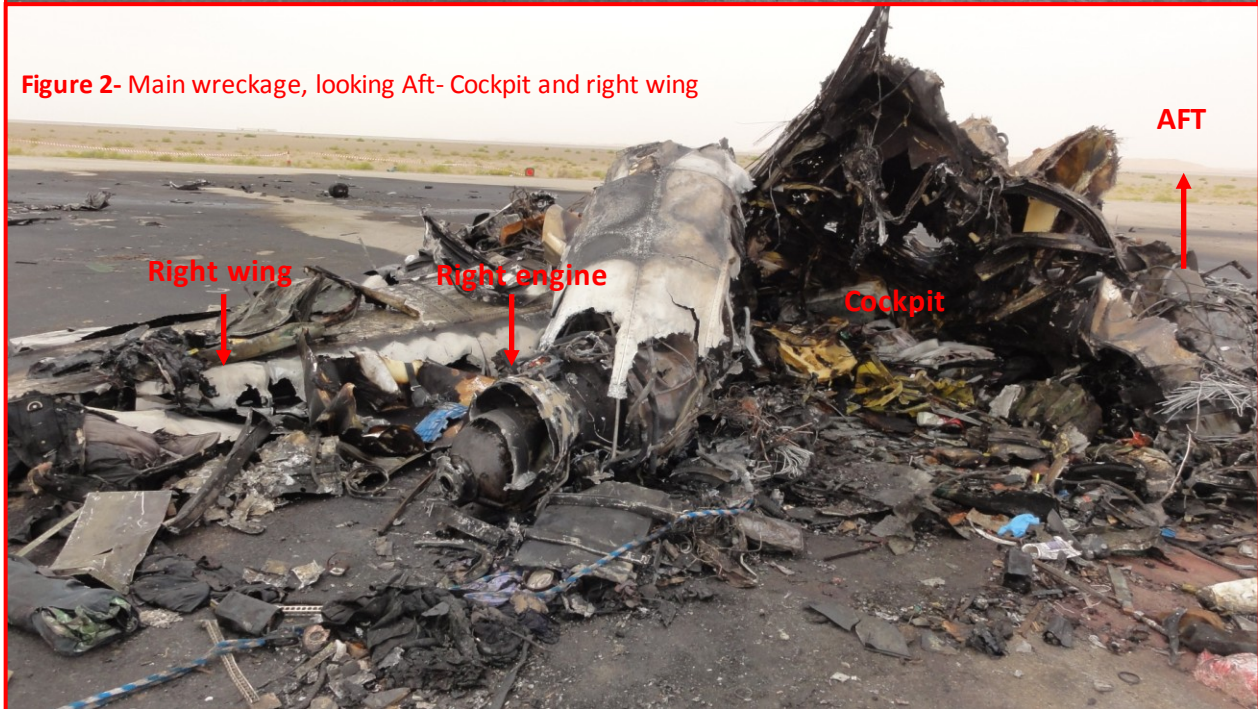
Figure 2- Main wreckage, looking Aft- Cockpit and right wing

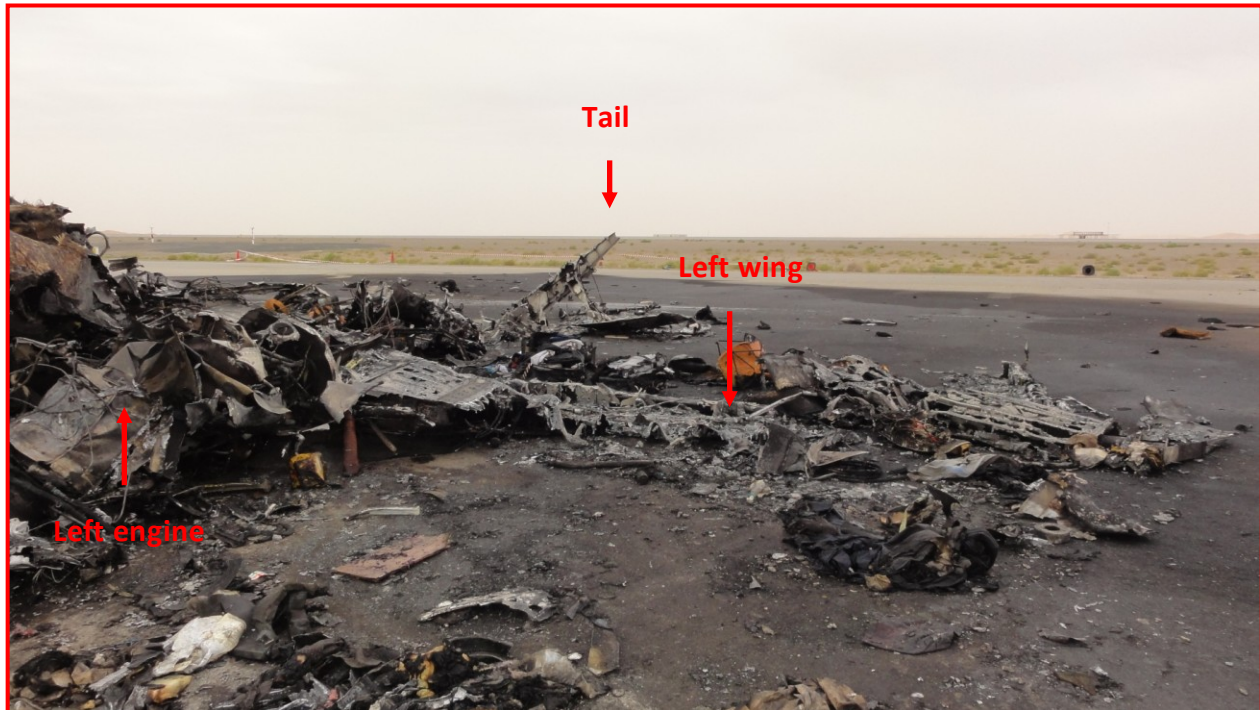
The post impact fire consumed the majority the Aircraft left side structure, whereas the right side exhibited less damage and burnt metals.

Figure 3- Main wreckage, looking Aft- Left wing
